# INVESTIGATION OF SA-501 S-IVB AUXILIARY PROPULSION SYSTEM FLIGHT ANOMALIES

*by K. Coates and E. Donald*

*George C. Marshall Space Flight Center  
Marshall, Ala.*

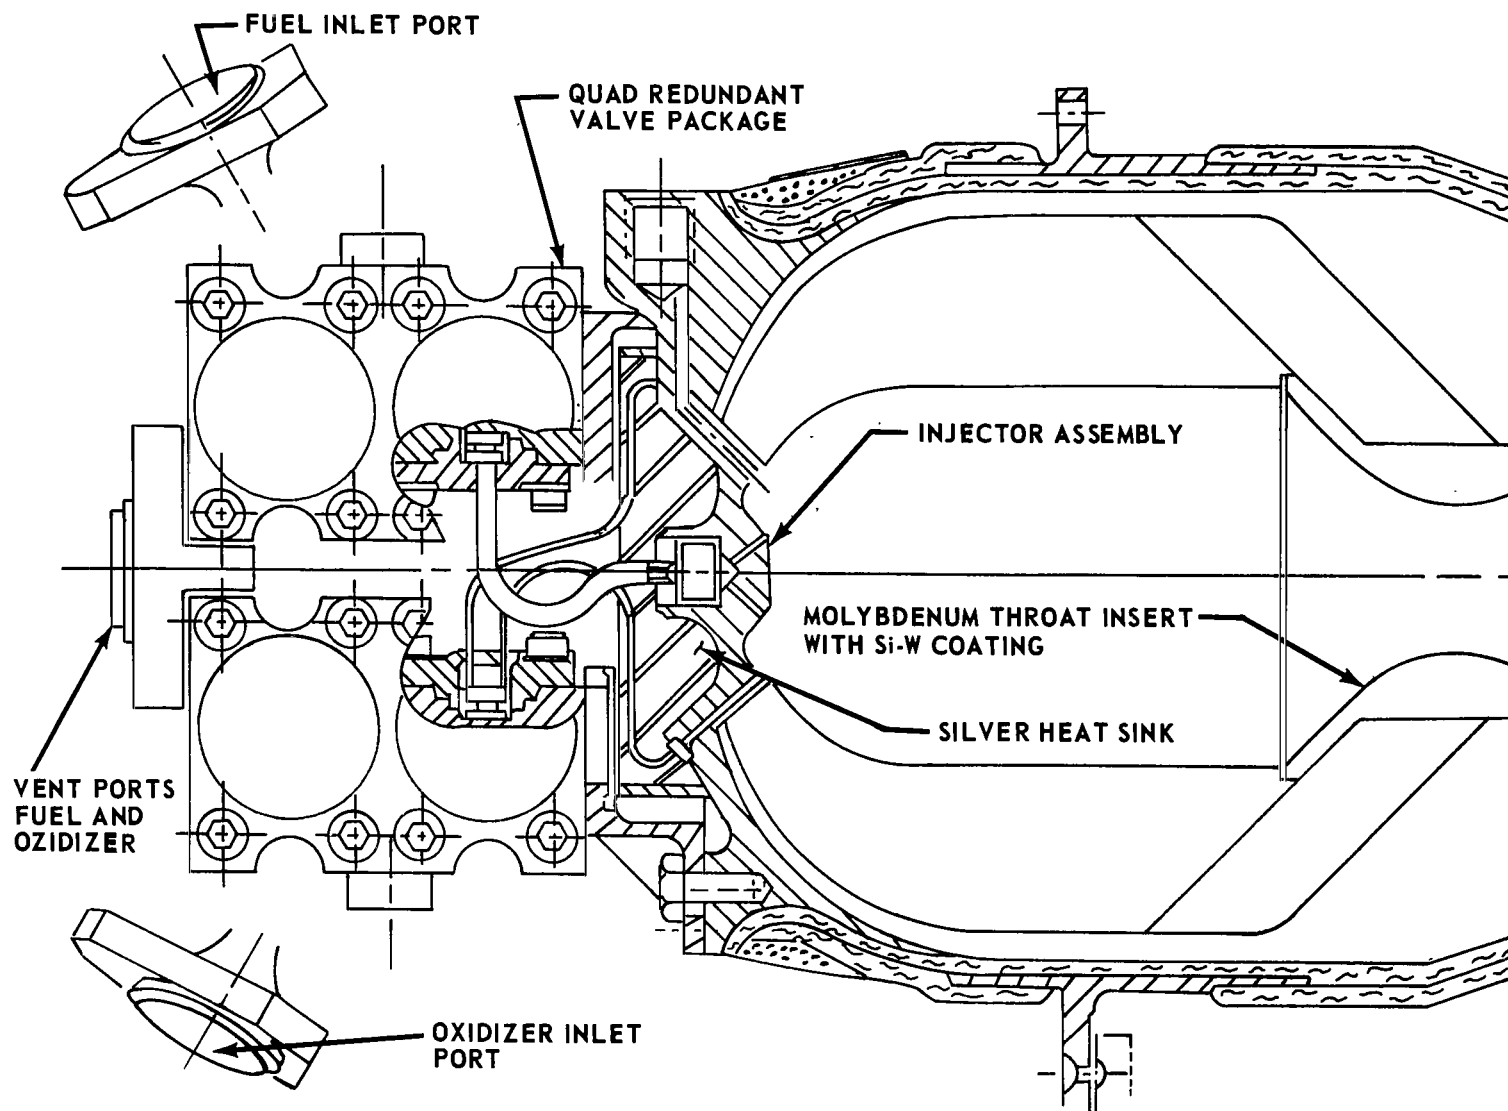
FIGURE 3. TAPCO ENGINE CUTAWAY

A cutaway view of the engine is shown in Figure 3. The engine flow path contains a 100 mesh (filtration level of 150 microns) screen filter at the valve entrance (recirculation line is downstream of filter), the solenoid operated quad valves, a flow control orifice at the valves outlet, 12 capillary feed tubes on the

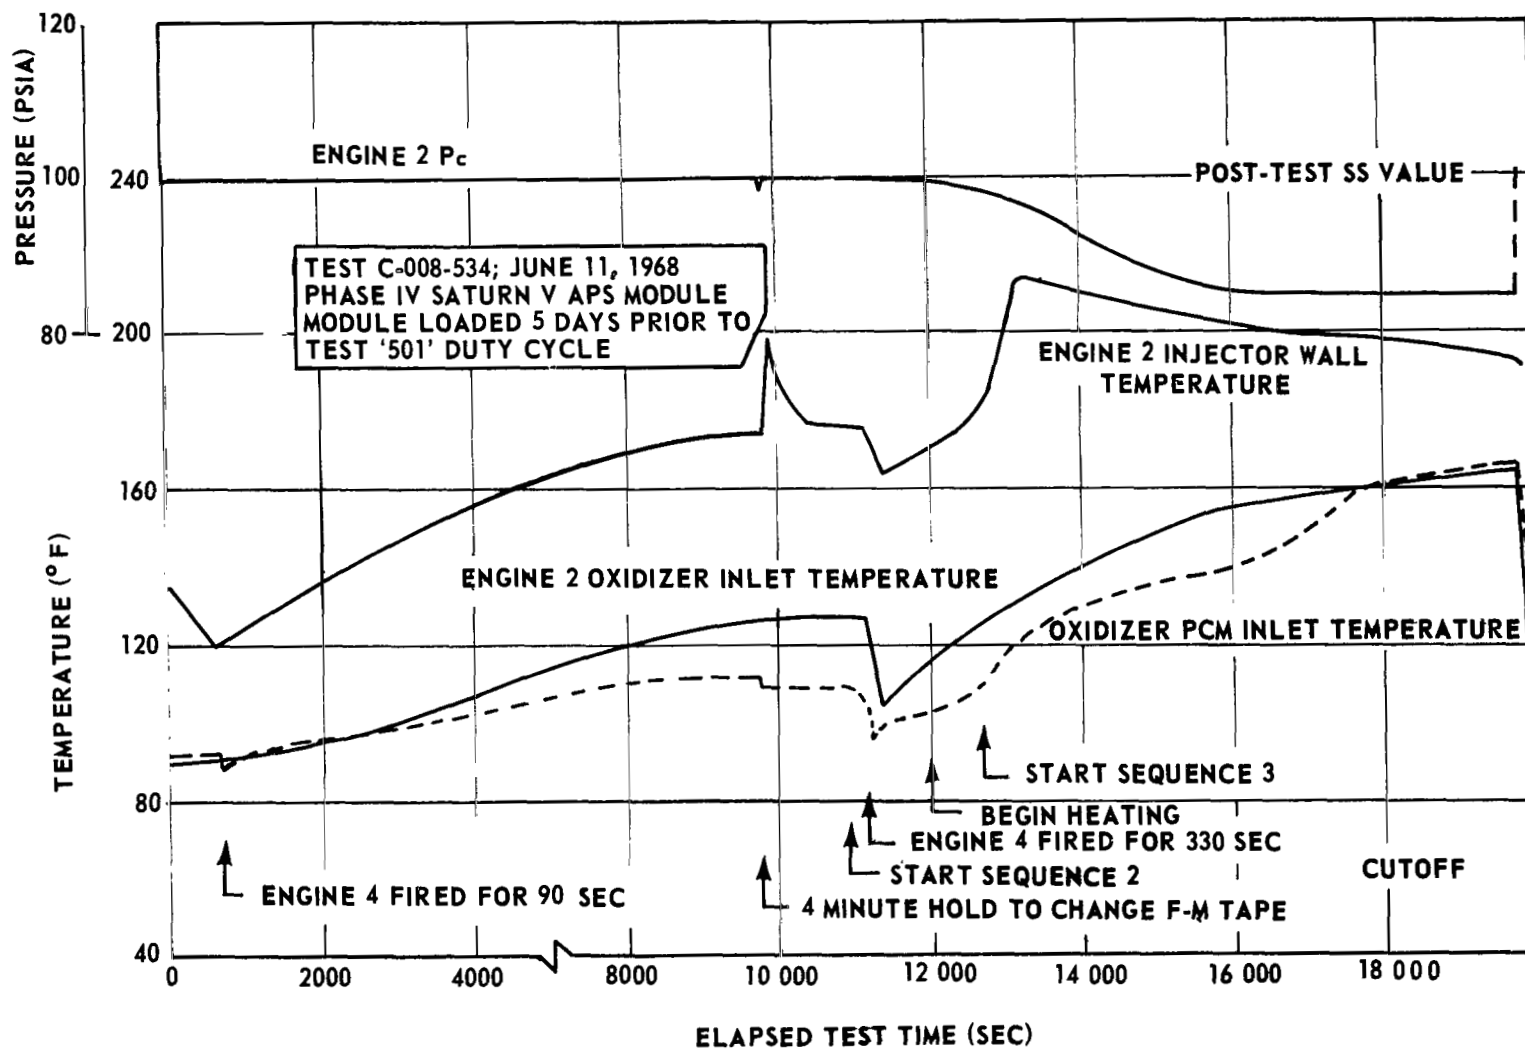
FIGURE 11. ENGINE 2  $P_c$ , INJECTOR TEMPERATURE, AND OXIDIZER SUPPLY TEMPERATURE VERSUS TEST TIME

The test data revealed a significant decay in engine Pc with increase in propellant and engine temperature. However, for the initial 12 000 seconds of the tests, there was little variation in the nominal Pc operating levels. The exceptions to this were the times that 3- to 4-minute hold periods were incurred in order to change the F-M recording tape. The initial engine pulses following this hold exhibited reduced Pc values. However, the nominal Pc values were restored after two or three pulses. It was noted that the engine temperatures "soaked out" at higher values during these hold periods. The dense portion of the firing cycle was begun at 10 900 seconds, followed by the beginning of heating of the oxidizer control module at 12 000 seconds. Pc decay began at this point (12 000 seconds) and continued throughout the remainder of the duty cycle. The Pc decay is best illustrated in Figures 10, 11, and 12, which contain curves of engine Pc, engine injector wall temperature, oxidizer inlet temperature, and oxidizer control module (PCM) inlet temperature versus test time for a typical test. The maximum experienced Pc decay in this test program was 32 psia. Note that the Pc values returned to nominal during the post-test steady state firings.
